Appendix F: Northwest R6208

Field Notes and Pictures

Utility: ComEd Investigators: J. Stutsman & J. Spencer

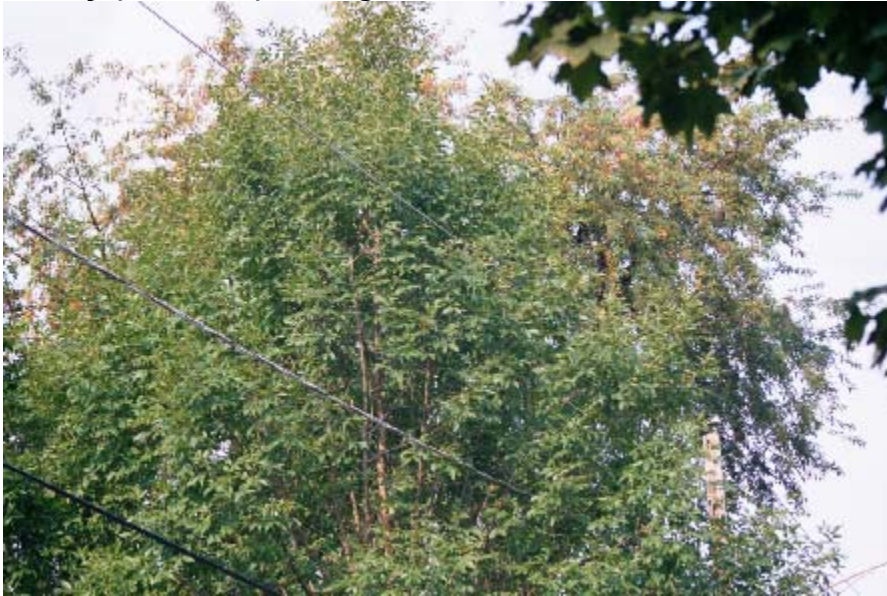
Picture F1

Insulated primary (tree wire) through hardwood tree at 1312 Kent St. in Rockford

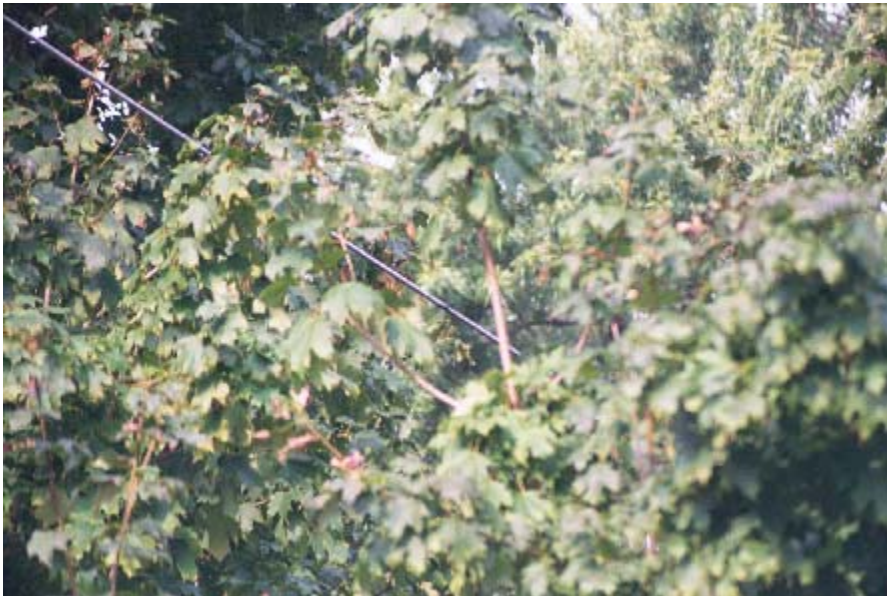
Picture F2

Insulated primary (tree wire) through hardwood Maple tree with burning on tree near 1218 Kent St. in Rockford

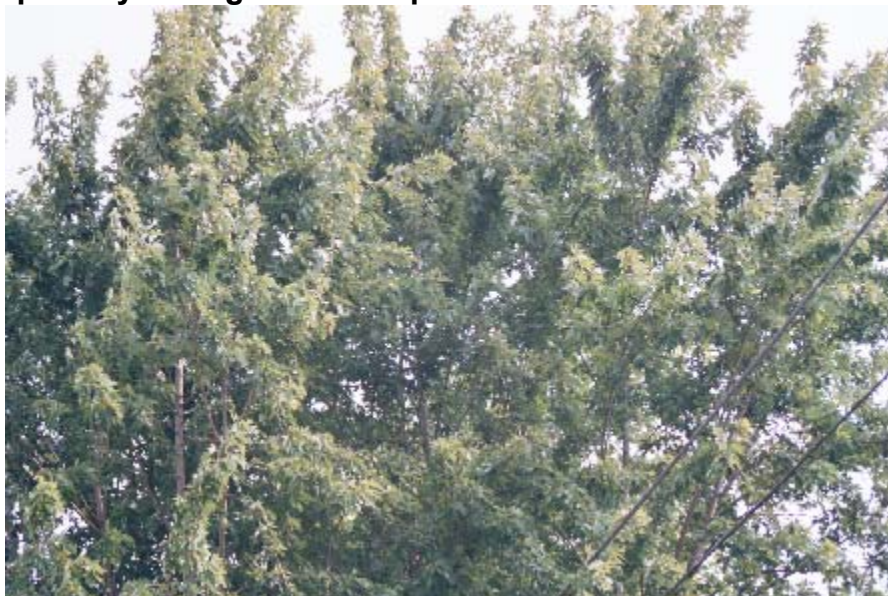
Picture F4

Bare primary through silver Maple near 2420 Rose Ave. in Rockford

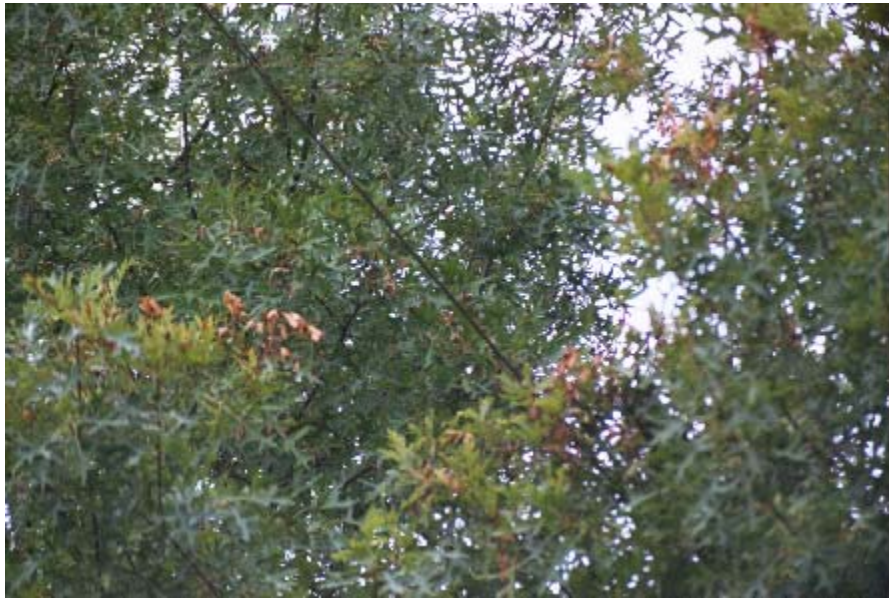
R6206	12kV	Rockford	8/9/01	Tree contact, primary looks like weather-proof-CU, multiple tree contacts -- several silver Maples and Elm trees -- along Ogilby Rd west from S Central Av
R6206	12kV	Rockford	8/9/01	Tree contact, south of Wisconsin Av between S Central Av and Clover Av
R6206	12kV	Rockford	8/9/01	Tree contact, south of Wisconsin Av between Rose Av and Holland Av
R6206	12kV	Rockford	8/9/01	Tree contact, 2420 Rose Ave. bare primary single phase through silver Maple tree -- see Picture F4
R6206	12kV	Rockford	8/9/01	Tree contact, 226-230 Cole Ave. bare primary through Cottonwood tree -- illustrative of entire block*
R6206	12kV	Rockford	8/9/01	Tree contact, 238 Cole Ave. bare primary through Oak tree with lots of burning -- entire block has lots of hardwood, slow growth, trees that look like they've never been trimmed in quite awhile -- see Picture F5
R6206	12kV	Rockford	8/9/01	Tree contact, 3021 Jean St. bare primary through trees with burning*

Bare primary through Oak tree with lots of burning on tree near 238 Cole Ave. in Rockford, this is typical of the entire block i.e. lots of hardwoods and slow growth trees – looks like it hasn't been for some time

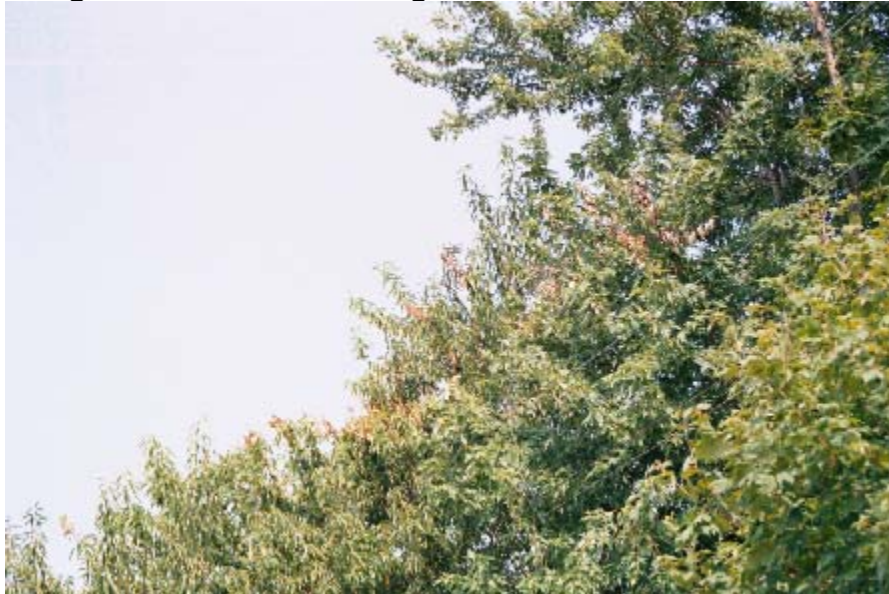
Picture F6

Bare primary through trees (various varieties of soft and hard) with lots of burning and “electro trimming” near 1301 Linda St. in Rockford
